PRESERVATION ASSESSMENT AND PLAN FOR THE OLD ATHENS CEMETERY, ATHENS, GEORGIA

Prepared By:
Michael Trinkley, Ph.D.
and
Debi Hacker

CHICORA RESEARCH CONTRIBUTION 459

December 22, 2006

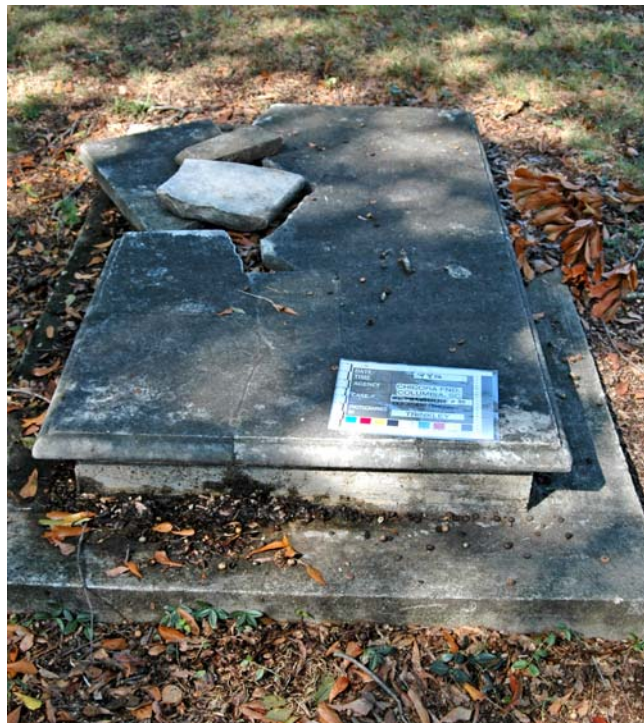
Existing Condition

Position: ☐ fallen ☐ tilted ☐ unstable ☒ unattached/loose ☐ missing

Deterioration: ☒ broken ☐ cracked ☐ losses ☐ flaking/sugaring ☐ ferrous pins ☐ brass pins
☐ delamination/detachment ☐ spalling ☒ missing fragments ☐ other:

Failed/Old Treatments: ☐ metal ☐ adhesives/coatings ☐ mortar ☒ other: nylon pins

Soiling: ☒ biological ☒ staining ☐ efflorescence ☐ other:

Position: ☐ reset/level in ground ☒ reset/level to existing base ☐ construct new base ☐ resquare
☐ possible new base required ☐ stabilize foundation ☒ reset with 0:1:3 mix ☐ reset with compound

Failed Treatments: ☐ drill/grind ☐ hand tools ☐ solvents ☒ other: remove nylon pins

Treatment: ☐ core drill ☒ drill and pin ☐ simple adhesive repair ☐ injection grout ☐ replace bricks
☐ mortar ☐ repoint ☒ other: infill with Jahn M120 Marble Mortar

Cost: \$1300

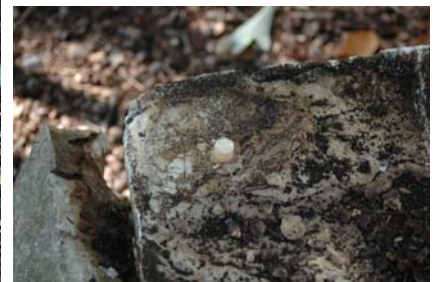
Type: ☐ hairpin ☐ hairpin & picket ☐ bow & picket ☐ bow & hairpin ☒ milled point ☒ other: ca. 12x6½ feet; one corner post is replacement

Position: ☐ fallen ☐ tilted ☐ unstable ☐ unattached/loose ☒ missing

Deterioration: ☐ broken ☐ cracked ☒ losses ☒ corrosion ☒ covered in soil ☒ missing fragments
☒ other: one post is a replacement; match is marginally acceptable; much loss from soil burial; five pickets are missing

Failed/Old Treatments: ☒ welds ☐ adhesives/coatings ☐ ferrous metals ☐ other:

Paint: ☐ test for lead ☐ air abrasion ☒ hand tools ☒ rust converter primer ☒ top coat alkyd flat paint (two coats) ☐ other:

Treatment: ☒ remove soil from fence bottom rails ☐ re-attach fence sections ☐ straighten sections
☐ caulk elements prior to painting ☒ other: will be necessary to stabilize soil to prevent future erosion and covering of fence bottom rail – all work to be performed within scope of repairs

Cost: \$950

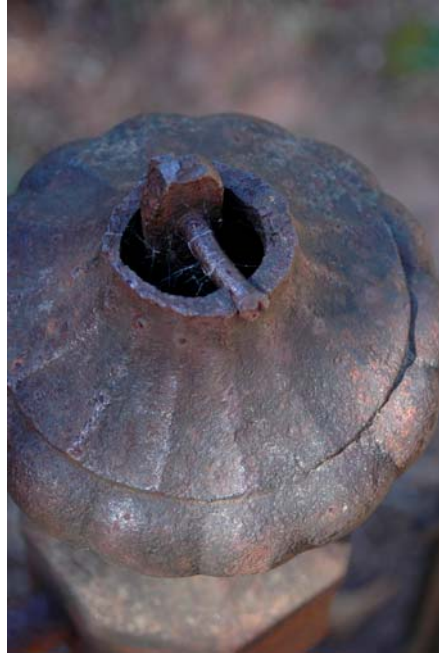
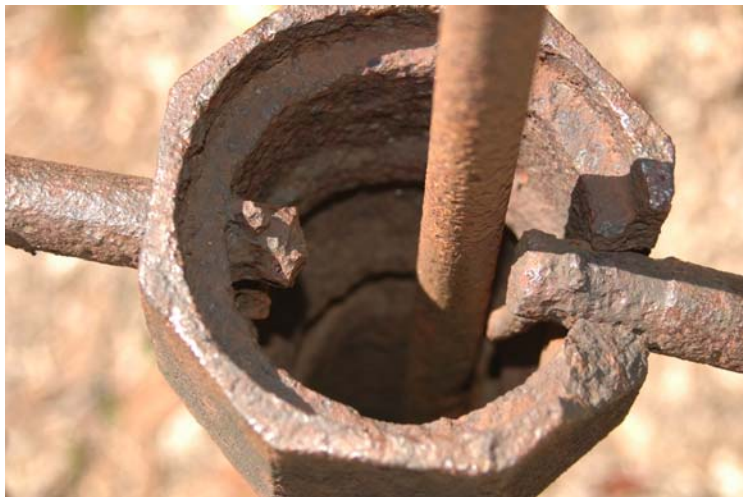
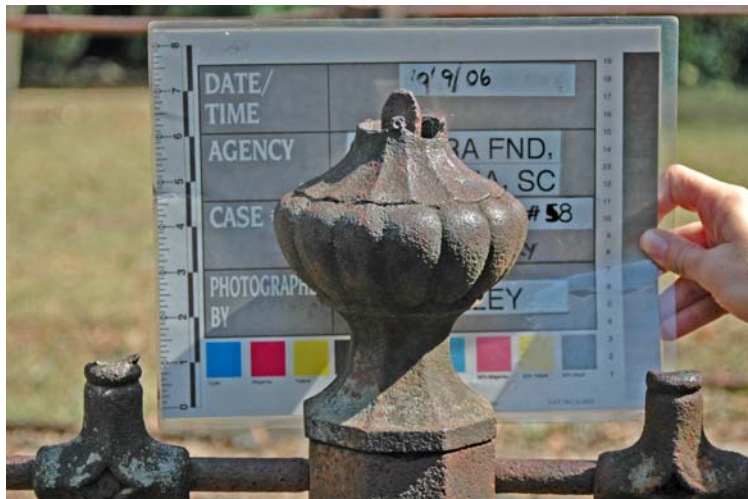
Position: ☐ fallen ☐ tilted ☐ unstable ☐ unattached/loose ☒ missing

Deterioration: ☒ broken ☐ cracked ☐ losses ☐ flaking/sugaring ☐ ferrous pins ☐ brass pins
☐ delamination/detachment ☐ spalling ☒ missing fragments ☐ other:

Failed/Old Treatments: ☐ metal ☒ adhesives/coatings ☐ mortar ☒ other: previous repair failed, top now missing

Soiling: ☒ biological ☒ staining ☐ efflorescence ☐ other:

Position: ☐ reset/level in ground ☐ reset/level to existing base ☐ construct new base ☐ resquare
☐ possible new base required ☐ stabilize foundation ☐ reset with 0:1:3 mix ☐ reset with compound

Treatment: ☐ core drill ☐ drill and pin ☐ simple adhesive repair ☐ injection grout ☐ replace bricks
☐ mortar ☐ repoint ☐ other:

Cost: n/c

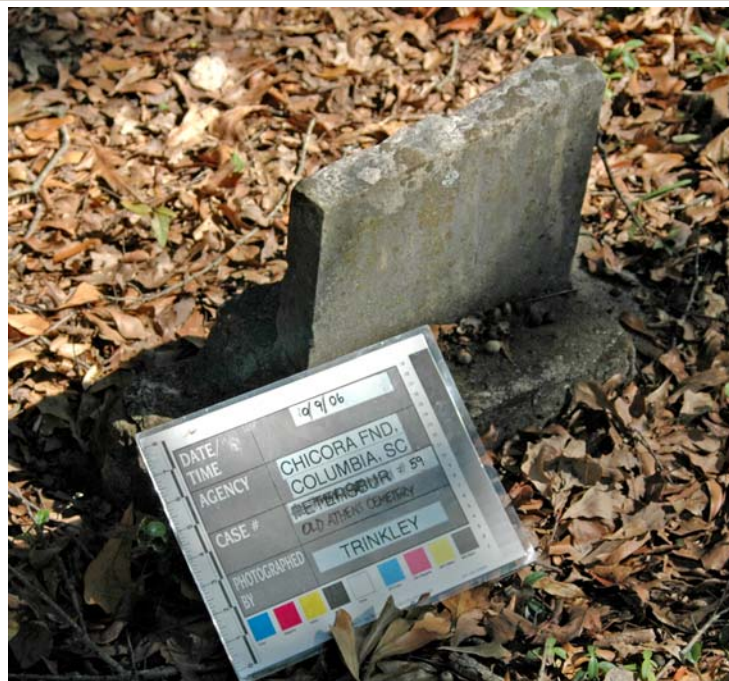
Old Athens Cemetery, Athens, GA Monument Treatment Proposal

Position: ☐ fallen ☐ tilted ☐ unstable ☐ unattached/loose ☒ missing

Deterioration: ☒ broken ☐ cracked ☐ losses ☐ flaking/sugaring ☐ ferrous pins ☐ brass pins
☐ delamination/detachment ☐ spalling ☒ missing fragments ☐ other:

Failed/Old Treatments: ☐ metal ☐ adhesives/coatings ☐ mortar ☒ other: old repair, failed and now missing

Soiling: ☒ biological ☒ staining ☐ efflorescence ☐ other:

Position: ☐ reset/level in ground ☒ reset/level to existing base ☐ construct new base ☐ resquare
☐ possible new base required ☐ stabilize foundation ☒ reset with 0:1:3 mix ☐ reset with compound

Treatment: ☐ core drill ☐ drill and pin ☐ simple adhesive repair ☐ injection grout ☐ replace bricks
☐ mortar ☐ repoint ☐ other:

Cost: \$300

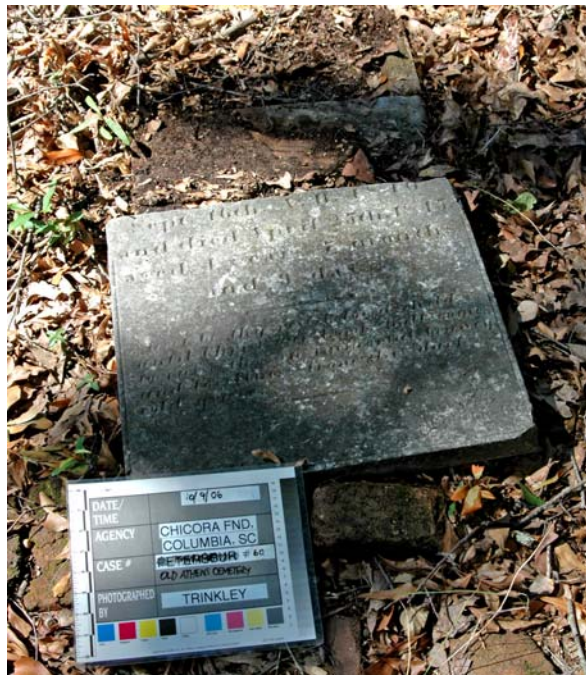
Old Athens Cemetery, Athens, GA
Monument Treatment Proposal

Position: ☐ fallen ☐ tilted ☐ unstable ☒ unattached/loose ☐ missing

Deterioration: ☒ broken ☐ cracked ☐ losses ☐ flaking/sugaring ☐ ferrous pins ☐ brass pins
☐ delamination/detachment ☐ spalling ☒ missing fragments ☐ other:

Soiling: ☒ biological ☒ staining ☐ efflorescence ☐ other:

Position: ☐ reset/level in ground ☒ reset/level to existing base ☐ construct new base ☐ resquare
☒ possible new base required ☐ stabilize foundation ☐ reset with 0:1:3 mix ☐ reset with compound

Treatment: ☐ core drill ☒ drill and pin ☐ simple adhesive repair ☐ injection grout ☐ replace bricks
☐ mortar ☐ repoint ☒ other: infill lost sections using Jahn M120 Marble Mortar & pin

Cost: \$1700

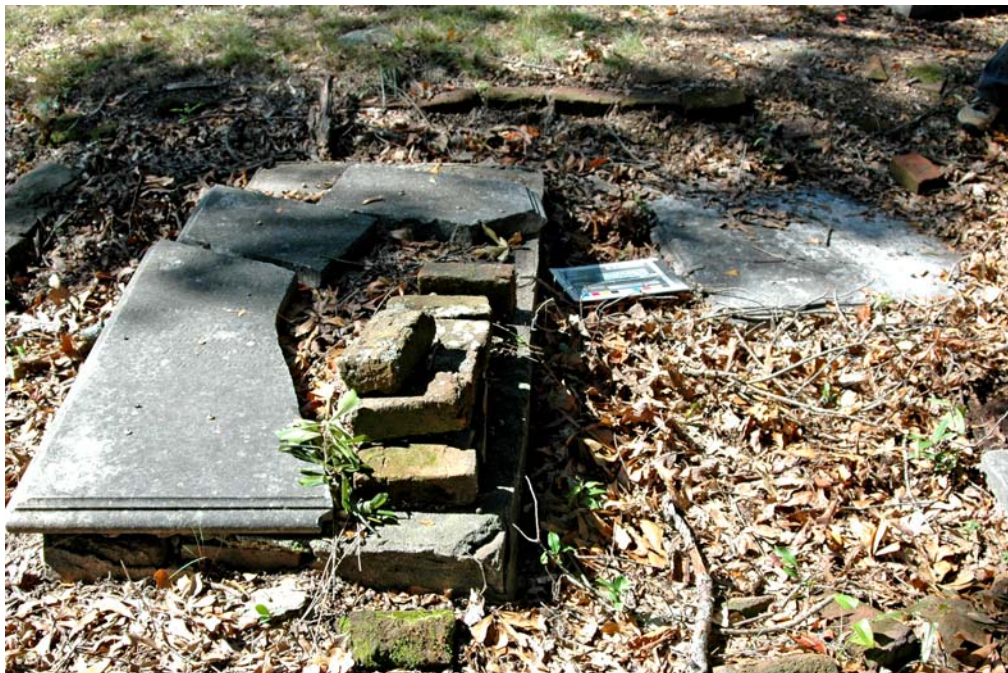
Old Athens Cemetery, Athens, GA Monument Treatment Proposal

Position: ☒ fallen ☐ tilted ☐ unstable ☒ unattached/loose ☒ missing

Deterioration: ☐ broken ☐ cracked ☐ losses ☐ flaking/sugaring ☐ ferrous pins ☐ brass pins
☐ delamination/detachment ☐ spalling ☐ missing fragments ☐ other:

Treatment: ☐ core drill ☐ drill and pin ☐ simple adhesive repair ☐ injection grout ☒ replace bricks
☐ mortar ☒ repoint ☒ other: stabilize where present

Cost: \$800

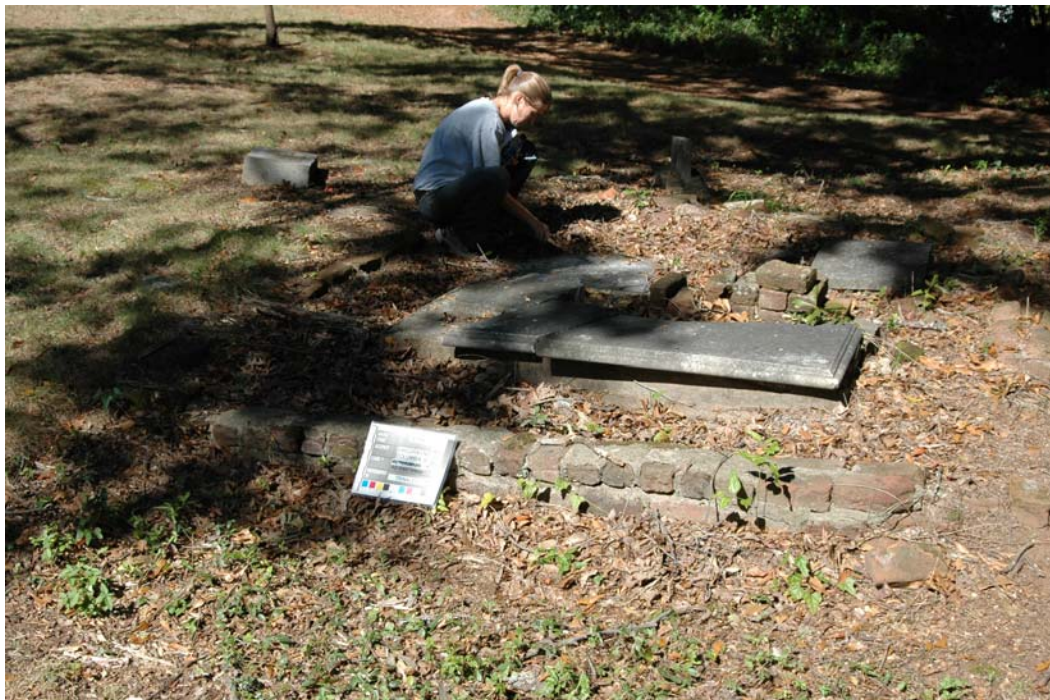
Old Athens Cemetery, Athens, GA Monument Treatment Proposal

Position: ☐ fallen ☐ tilted ☒ unstable ☐ unattached/loose ☐ missing

Deterioration: ☒ broken ☐ cracked ☐ losses ☐ flaking/sugaring ☐ ferrous pins ☐ brass pins
☐ delamination/detachment ☐ spalling ☐ missing fragments ☐ other:

Soiling: ☒ biological ☒ staining ☐ efflorescence ☐ other:

Position: ☒ reset/level in ground ☐ reset/level to existing base ☐ construct new base ☐ resquare
☐ possible new base required ☐ stabilize foundation ☐ reset with 0:1:3 mix ☐ reset with compound

Treatment: ☐ core drill ☒ drill and pin ☐ simple adhesive repair ☐ injection grout ☐ replace bricks
☐ mortar ☐ repoint ☒ other: infill with Jahn M120 Marble Mortar

Cost: \$800

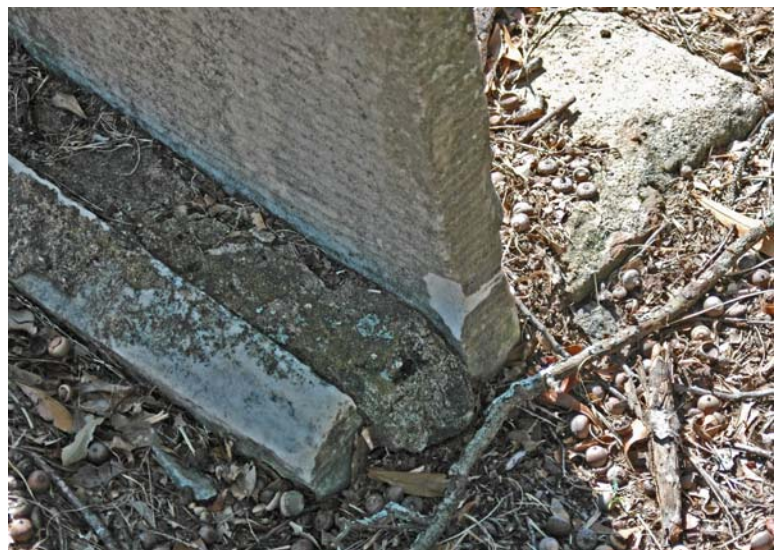
Position: ☒ fallen ☐ tilted ☐ unstable ☐ unattached/loose ☐ missing

Deterioration: ☐ broken ☐ cracked ☐ losses ☐ flaking/sugaring ☐ ferrous pins ☐ brass pins
☐ delamination/detachment ☐ spalling ☐ missing fragments ☒ other: old repair, now failed

Failed/Old Treatments: ☐ metal ☐ adhesives/coatings ☐ mortar ☒ other: nylon pins/epoxy

Soiling: ☒ biological ☒ staining ☐ efflorescence ☐ other:

Position: ☒ reset/level in ground ☒ reset/level to existing base ☐ construct new base ☐ resquare
☐ possible new base required ☐ stabilize foundation ☐ reset with 0:1:3 mix ☐ reset with compound

Cost: \$800
